**NUMBER:** 25-001-07

I/M Readiness Check Continues To Indicate OBD System Is Not Ready For I/M Testing

This bulletin involves modifying wiring in the Power Distribution Center (PDC).

2005 - 2006 (TJ) Wrangler

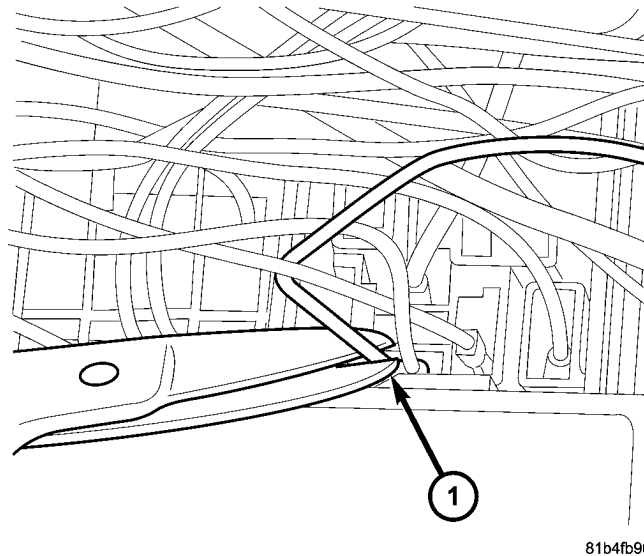
**Fig. 2 CUT ASD 20 GA PK/WT TO FUEL PUMP**

1 - CUT PDC CAVITY A13 PK/WT WIRE THAT GOES TO THE FUEL PUMP RELAY CLOSE TO TERMINAL

7. At PDC cavity A13 (ASD), locate the one PK/WT wire that connects to the fuel pump relay terminal.
8. Cut the PK/WT wire, that connects to the fuel pump relay, as close to the PDC cavity A13 terminal as possible, (Fig. 2).
